## **Olentangy Trail - Final Gap**

## **North Broadway Crossing Safety Enhancement Summary**

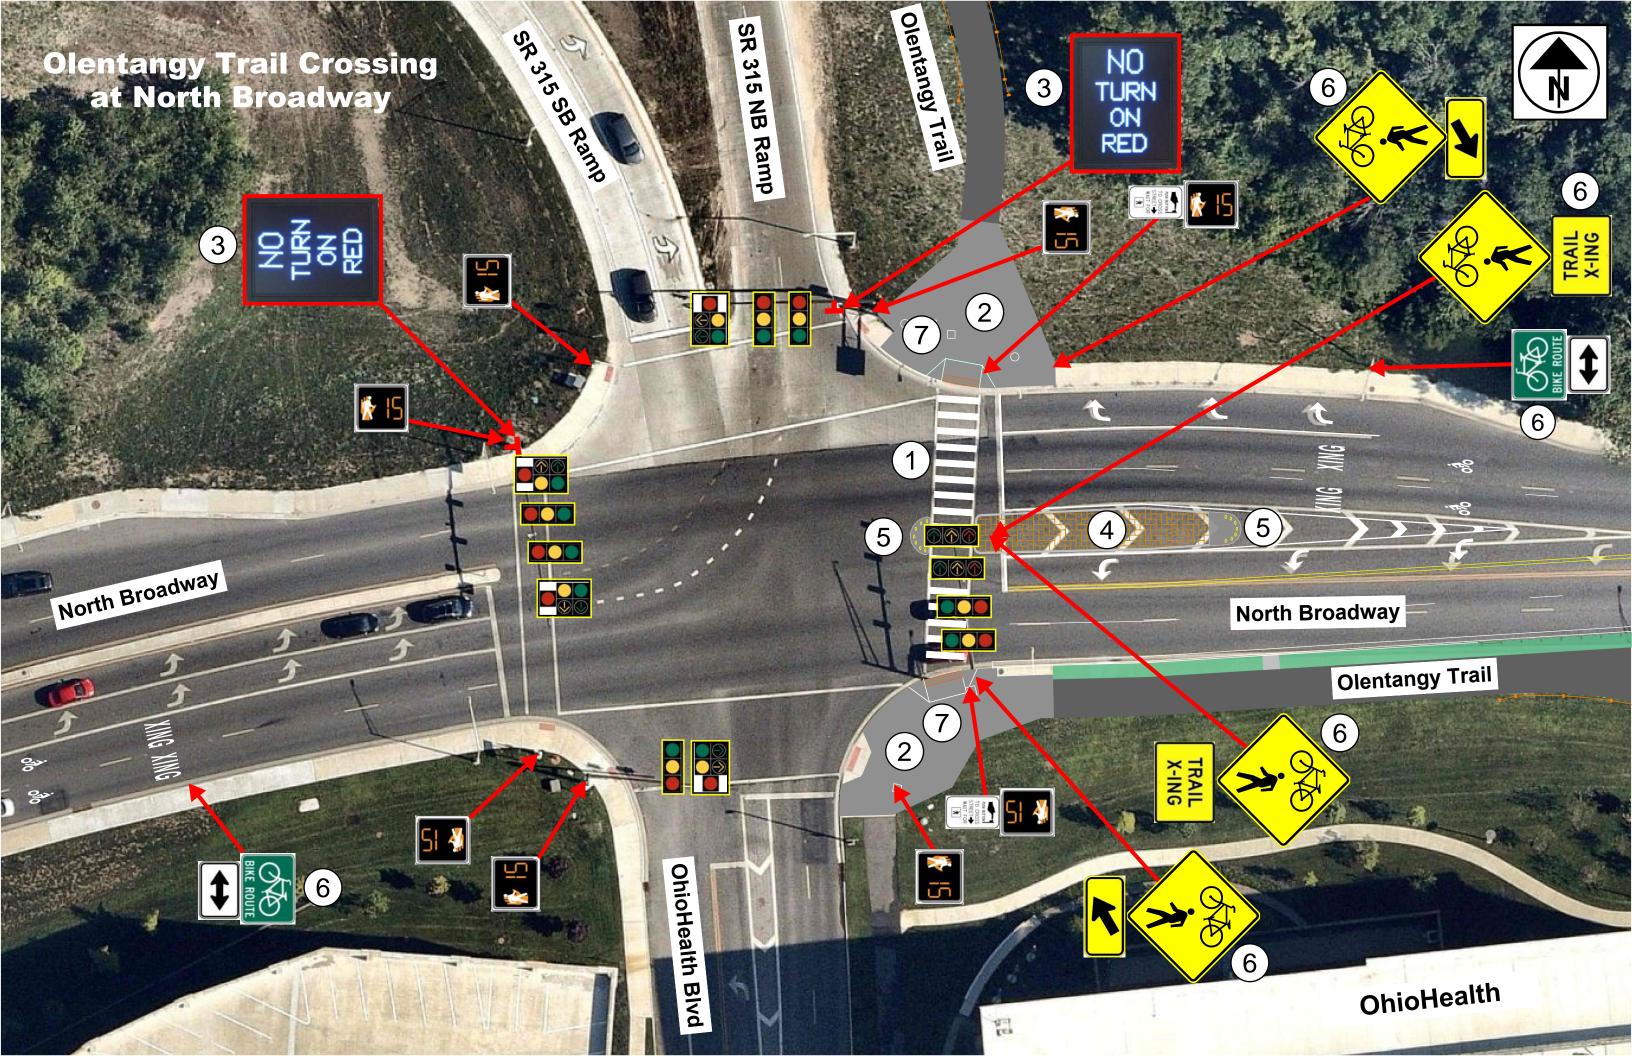
Because of the anticipated high volume of pedestrians and cyclists crossing North Broadway when this section of the Olentangy Trail is completed, the following safety improvements are being installed as part of the project:

- 1 High visibility ladder-style pavement markings on the east leg of the intersection where the trail crosses North Broadway.
- (2) Plaza "queueing areas" on the north and south side of North Broadway to provide adequate space for trail users waiting for the crossing signal.

- 3 High visibility, oversized LED "No Turn On Red" signs that are activated during the crossing phase when trail users press the pedestrian crossing button. These signs will add a significant increase in visibility.

- (4) Raised concrete median constructed within the existing striped area separating the westbound through lanes from the westbound left turn lane to slow traffic on North Broadway approaching the intersection.

- (5) Reboundable plastic pylons on the raised concrete median to further identify the crossing as a high pedestrian area.
- 6 Enhanced signage in the eastbound and westbound direction, including yellow "Trail Crossing" signs.

- (7) A Leading Pedestrian Interval (LPI) added to the signal timing. An LPI will give trail users a three to seven second head start when entering the crosswalk before the corresponding green light signal activates for motorists.

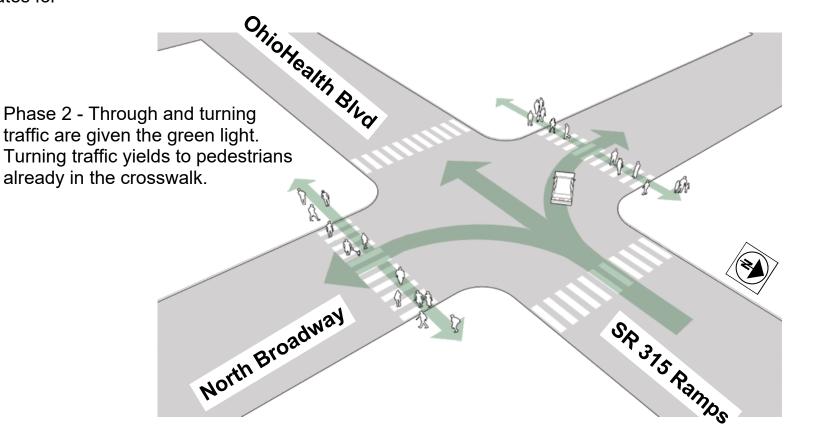
"No Turn On Red" LED sign turned off.

"No Turn On Red" LED sign turned on during pedestrian WALK phase.
