# NORTH CENTRAL COMMUNITY STREET TREE INVENTORY SUMMARY REPORT

THE CITY OF  
**COLUMBUS**  
RECREATION AND PARKS

FALL 2021

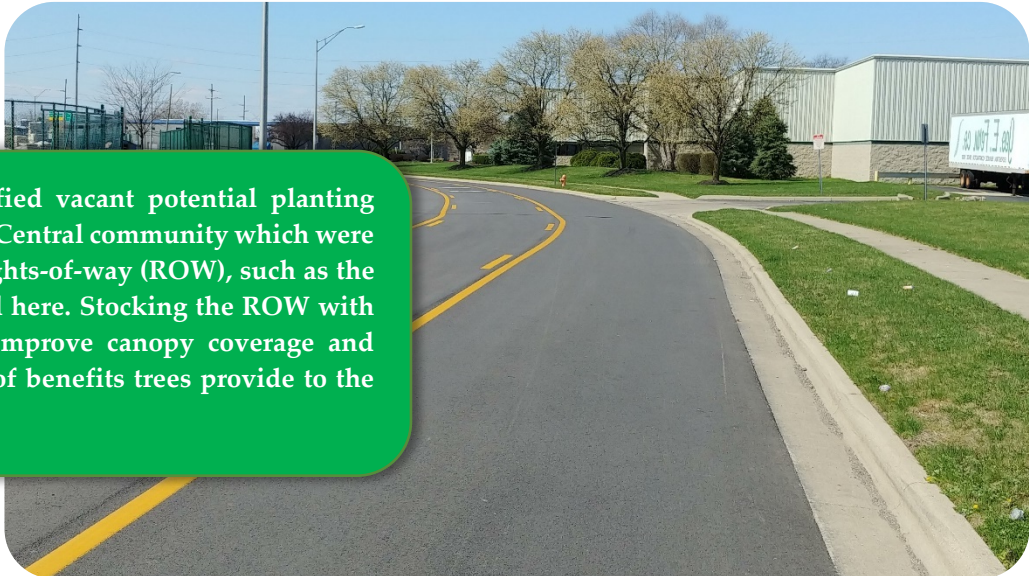
DRG arborists identified vacant potential planting sites within the North Central community which were located along street rights-of-way (ROW), such as the planting strip pictured here. Stocking the ROW with new trees will help improve canopy coverage and increase the quantity of benefits trees provide to the community.

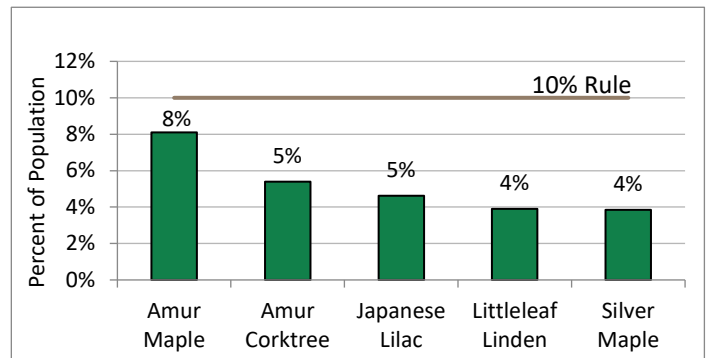
Figure 2. Species distribution of inventoried trees.

**A total of 102 tree species were catalogued during the inventory.** Of the five most abundant tree species recorded during the inventory, none exceeded the recommended 10% threshold (Figure 2).

Amur maple (*Acer ginnala*) is the most abundant species found within the community's street rights-of-way, accounting for 8% of all inventoried trees.

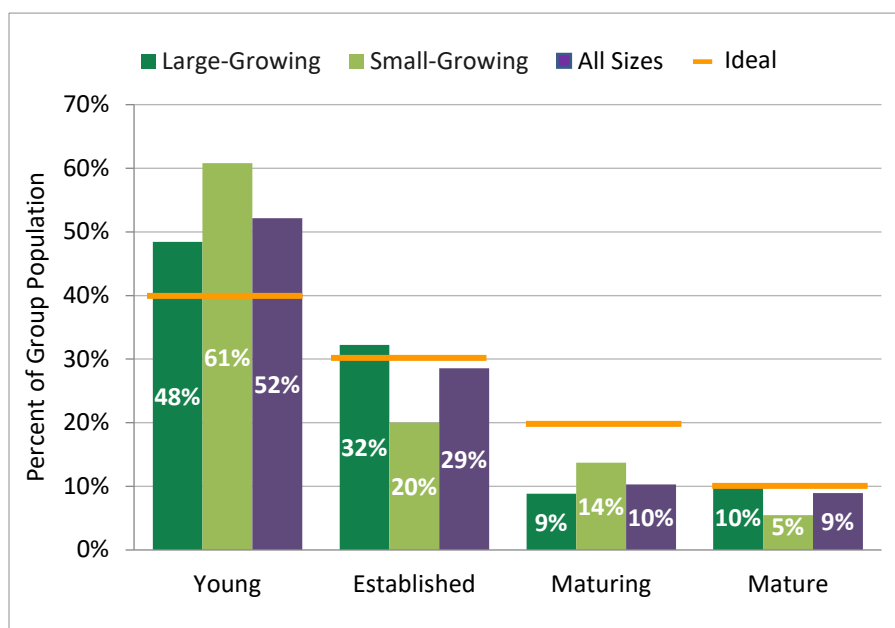
**Figure 5.** Distribution of relative tree age by diameter size-class.

Understanding the relative age of a tree population can help planners align future management strategies with current policy goals. To determine relative tree age, DRG first categorized North Central's inventoried tree population by small- and large-growing trees and then assigned each tree to an age grouping based on the tree diameter measured at breast height (DBH), as outlined in Table 1.<sup>1</sup>

The relative age distribution of North Central's inventoried tree population was then compared to an ideal distribution for an expanding urban forest, which suggests the tree population composition be equivalent to 40% young trees, 30% establishing, 20% maturing, and 10% mature trees (Figure 5).

### The Overall Street Tree Population is Young

The maturing age group is critical for ensuring sufficient succession and expansion of mature tree canopy cover. Maintenance and preservation of the existing trees in this age group should be prioritized to ensure uninterrupted canopy expansion and succession.

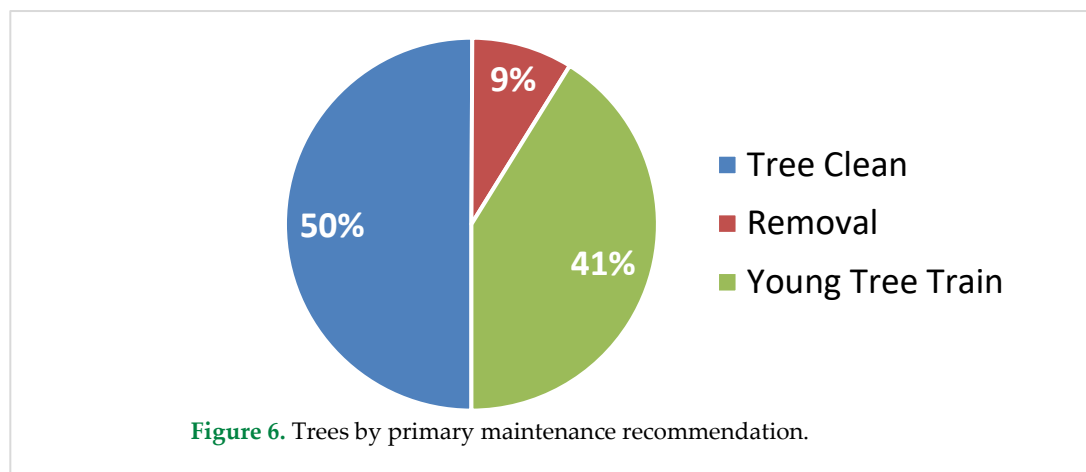
During the inventory, DRG arborists assigned a primary and secondary recommended maintenance activity to each of the 2,075 inventoried trees.

#### Tree Cleaning = 1,039 Trees

Tree cleaning describes pruning to remove dead, dying, broken, decayed, and/or crossing limbs. Trees in this category are recommended for inclusion in a regularly scheduled, routine maintenance program. Over time, routine pruning minimizes the occurrence of reactive maintenance.

#### Tree Removal = 182 Trees

In North Central, 182 trees are designated for removal. City Forestry only removes trees that are hazardous: either dead, dying, or dangerous to public safety.

#### Young Tree Training = 854 Trees

Younger trees can have branch structures that lead to potential problems as the tree ages. These trees should be pruned to train future growth patterns and correct or eliminate weak, interfering, or objectionable branches to minimize future maintenance requirements.

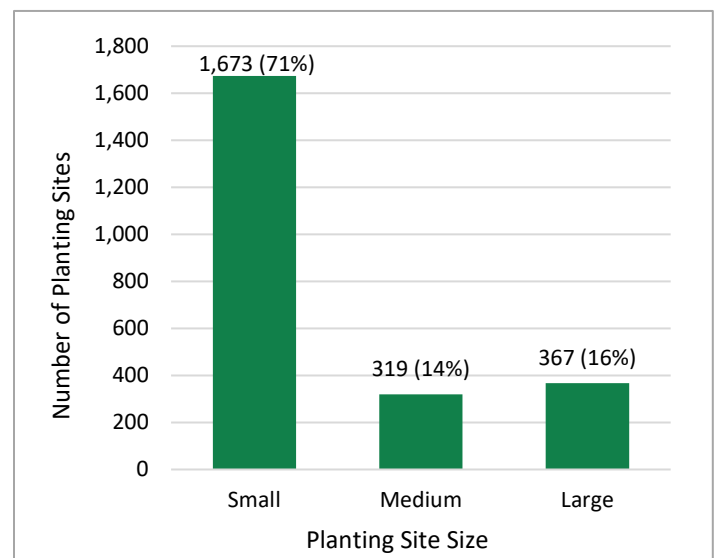
Figure 8. Planting sites by quantity and type.

**DRG arborists found a total of 585 vacant sites potentially suitable for planting trees.**<sup>4</sup> Sites were categorized as small, medium, or large. In addition to the data collection guidelines summarized below, DRG considered the presence of existing utilities, overhead lines, and distances from stop signs, fire hydrants, driveways, and other existing infrastructure.

#### 1,673 Small Planting Sites

- Best suited for small-maturing trees.
- Minimum width of 3 to 5 feet.
- Located at least 20 feet from another tree.
- Includes all sites with overhead utilities, regardless of site width.

#### 319 Medium Planting Sites

- Best suited for medium-maturing trees.
- Minimum width of 5 to 7 feet.
- Located at least 30 feet from another tree.

#### 367 Large Planting Sites

- Best suited for large-maturing trees.
- Minimum width of greater than 7 feet.
- Located at least 40 feet from another tree.
- The highest quality potential planting site.

Larger trees provide residents with greater benefits. Within North Central, 367 large and 319 medium sites were identified. Planting only these locations will increase the amount of street trees by 33% and provide a solid foundation to build upon for improving community canopy cover.
