HAYDEN RUN COMMUNITY STREET TREE INVENTORY SUMMARY REPORT

THE CITY OF
COLUMBUS
RECREATION AND PARKS

SPRING 2023

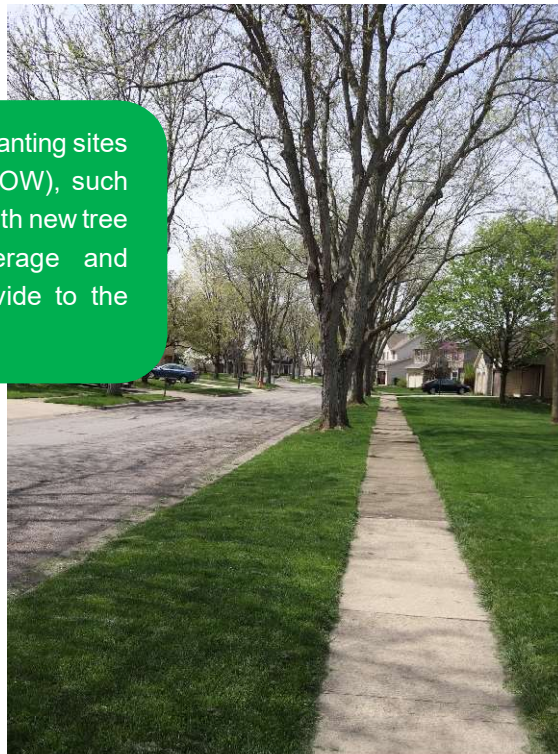
DRG arborists identified vacant potential planting sites within Hayden Run’s street rights-of-way (ROW), such as the one pictured here. Stocking the ROW with new tree plantings will help improve canopy coverage and increase the quantity of benefits trees provide to the community.

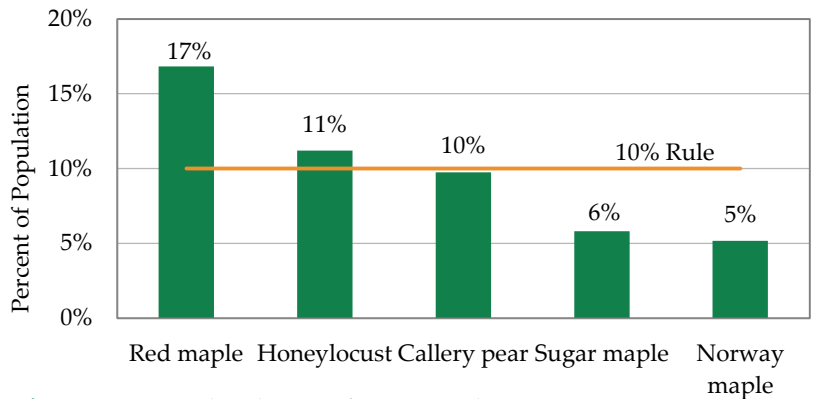
Figure 2. Species distribution of inventoried trees.

A total of 92 unique tree species were catalogued. Of the five most abundant tree species recorded during the inventory, two species, red maple and honeylocust, exceeded the recommended 10% threshold (Figure 2). Red maple (*Acer rubrum*) is the most abundant species found within the community’s street ROW, accounting for 17% of all inventoried trees. Honeylocust (*Gleditsia triacanthos*) accounts for 11%.

Future planting initiatives should minimize the installation of additional maple within Hayden Run until representation of the genus *Acer* falls within the recommended 20% threshold.

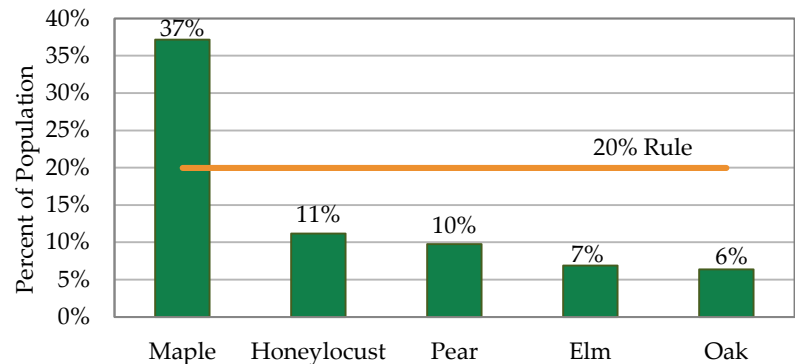
Figure 3. Genus distribution of inventoried trees.

Hayden Run has 42 unique tree genera, or groups of tree species, that are closely related (Figure 3). The genus *Acer*, which is composed of maple trees, accounts for 37% of the entire inventoried population—much higher than the suggested threshold of 20%.

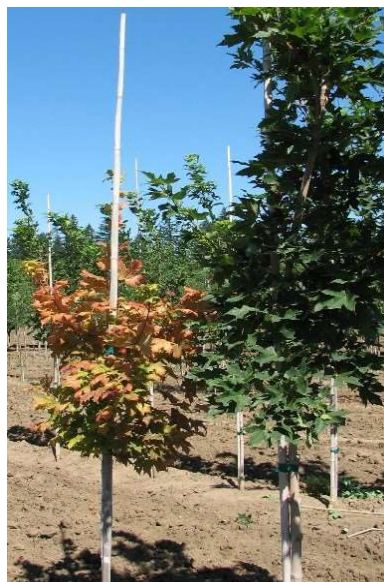
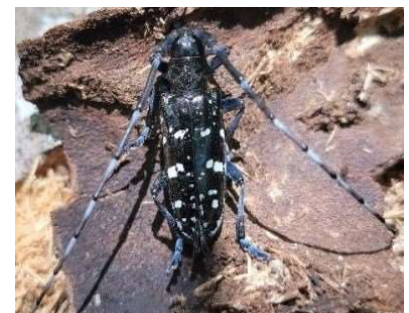
Maple trees are susceptible to a variety of harmful pests and disease, including the fungal pathogen Verticillium wilt (*Verticillium* spp.) and the invasive Asian longhorned beetle (ALB, *Anoplophora glabripennis*). Improved genus diversity will reduce the potential for tree loss and help ensure long-term urban forest health and viability.

Above: Asian Longhorned Beetle. Photo: Jeff Tessner, DRG.

Left: Sugar maple with Verticillium wilt. Photo: Jerry Weiland, USDA-ARS.
